Analysis of the Video from the 9-30-2008 Fullerton, CA Cessna 172S Crash (LAX08FA301)

Dan Horak
2-17-2009

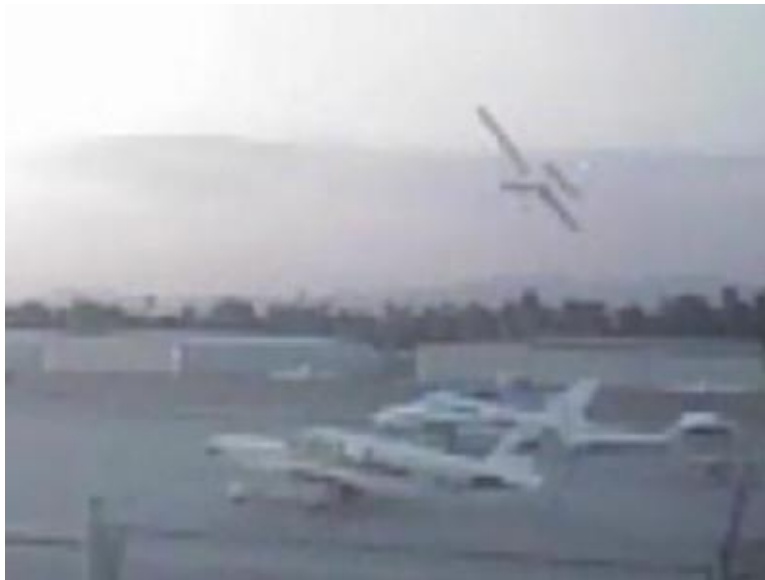
Figure 2 Aircraft at Time 6:37:41 – Camera 12

Figures 2 and 3 do not have sufficient resolution for determining the flap settings. Images acquired by cameras 10 and 11 have the same low resolution and, therefore, flap settings cannot be determined based on the video from the three cameras.

At time 6:37:41 (see Figure 2), the aircraft still has a relatively small pitch angle but its roll angle seems to be already about 45° . At time 6:37:42 (see Figure 3), the roll angle is about 75° and the longitudinal (X) body axis is beginning to point down from horizontal. To determine the orientation of the aircraft at time of impact, one has to rely on extrapolation based on Figures 2 and 3, on the damage to the aircraft, on the statement of eyewitness Thadeuss Perkins, and on the interview with the pilot.

There is insufficient video evidence for estimating the speed of ground impact accurately. Figures 2 and 3 and the pilot interview indicate that the aircraft was turning right relative to the runway during the last 2 seconds of flight. That direction is away from the cameras and, therefore, the aircraft velocity component to the right (perpendicular to the runway) could not be estimated. The average velocity component along the runway between times 6:37:41 and 6:37:42 was estimated to be 39 knots. Since, as seen in Figures 2 and 3, the turn to the right during that second was significant, the velocity component perpendicular to the runway at 6:37:42 was significant, possibly resulting in airspeed as high as 70 knots.

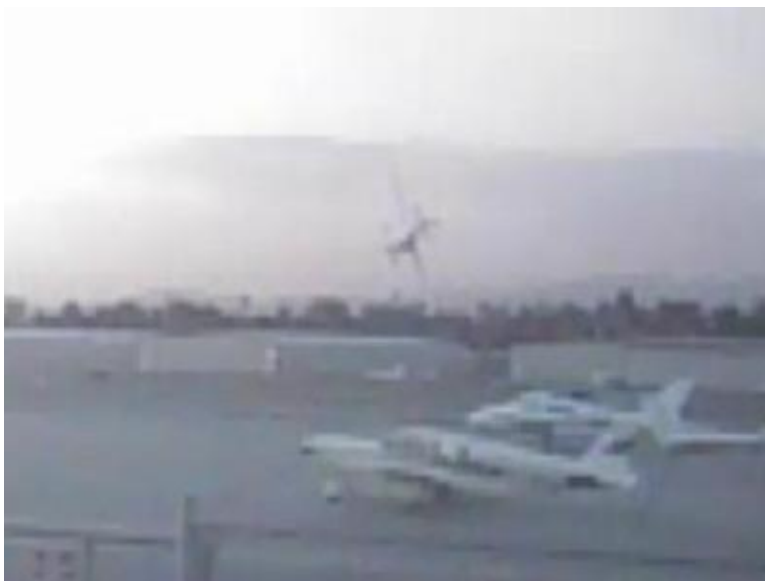
Figure 3 Aircraft at Time 6:37:42 – Camera 12

The last fraction of a second, from 6:37:42 till impact, is difficult to analyze. The aircraft flies away from the camera with a roll angle close to 90°, its fuselage rotates about 50° in the yaw direction, then the right wing tip hits the ground, the aircraft cartwheels about that contact point with the ground, and the nose impacts the ground. It is not possible to estimate accurately the speed with which the nose impacted the ground. It was probably somewhere in the 40 to 70 knots range.

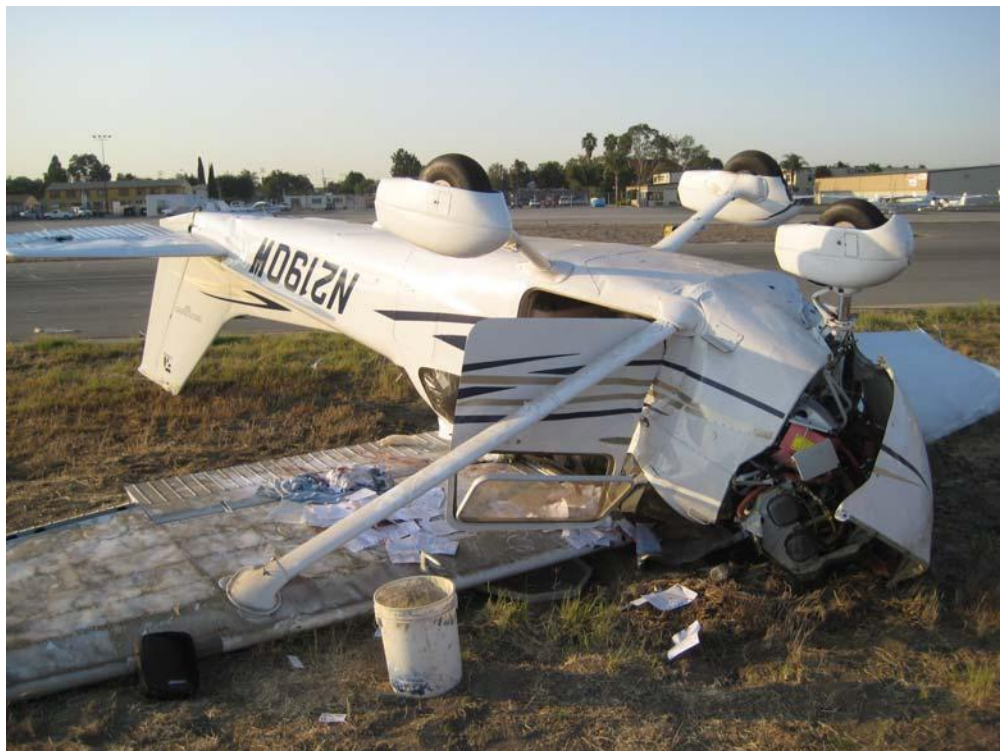
Figure 4 The Damaged Aircraft

A photograph of the damaged aircraft is in Figure 4. It shows that most of the ground impact was absorbed by the nose because the wings are still relatively intact and attached perpendicularly to the fuselage. This means that the aircraft hit the ground with no more than about 20° yaw attitude.

The statement by eyewitness Thadeuss Perkins supports this conclusion when he states that *“Then I saw the right wing strike the runway as the nose of the Cessna seemed to be perpendicular with the runway. Then the nose of the Cessna struck the runway in a cartwheel motion”*. The pilot stated that *“the plane finally did go to the right and then nosed over and went right back down”*, also supporting the nose-down impact theory.
